## Inspector's Daily Report

IDR Sheet	1	of	3	Sheets
Contract	Day				Date
C7852	Friday				May 27, 2011

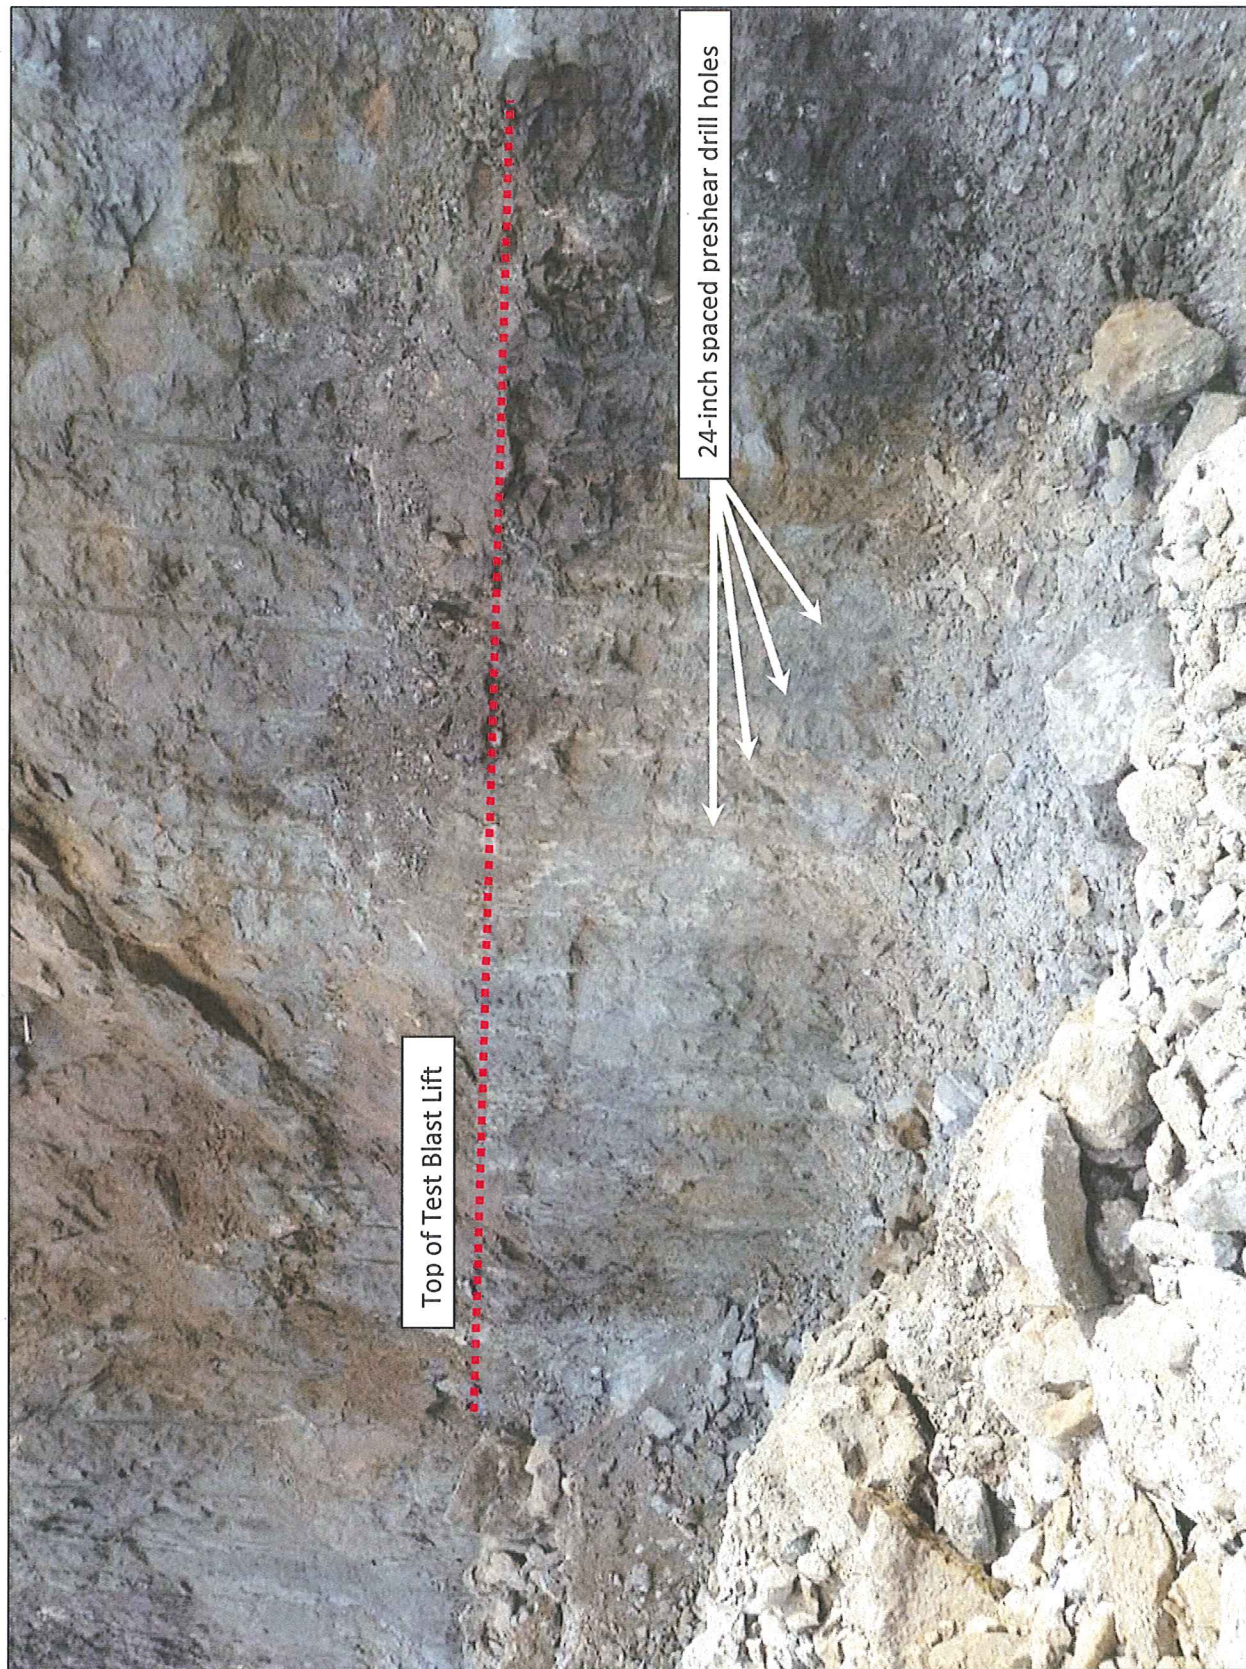
**Figure 1.** The freshly exposed face of the template #4 test blast section between approximately LW Station 1327+00 and 1327+75. The preshear drill holes are evenly spaced vertically and horizontally along the finished face. This is a vast improvement from the drilling accuracy last season.

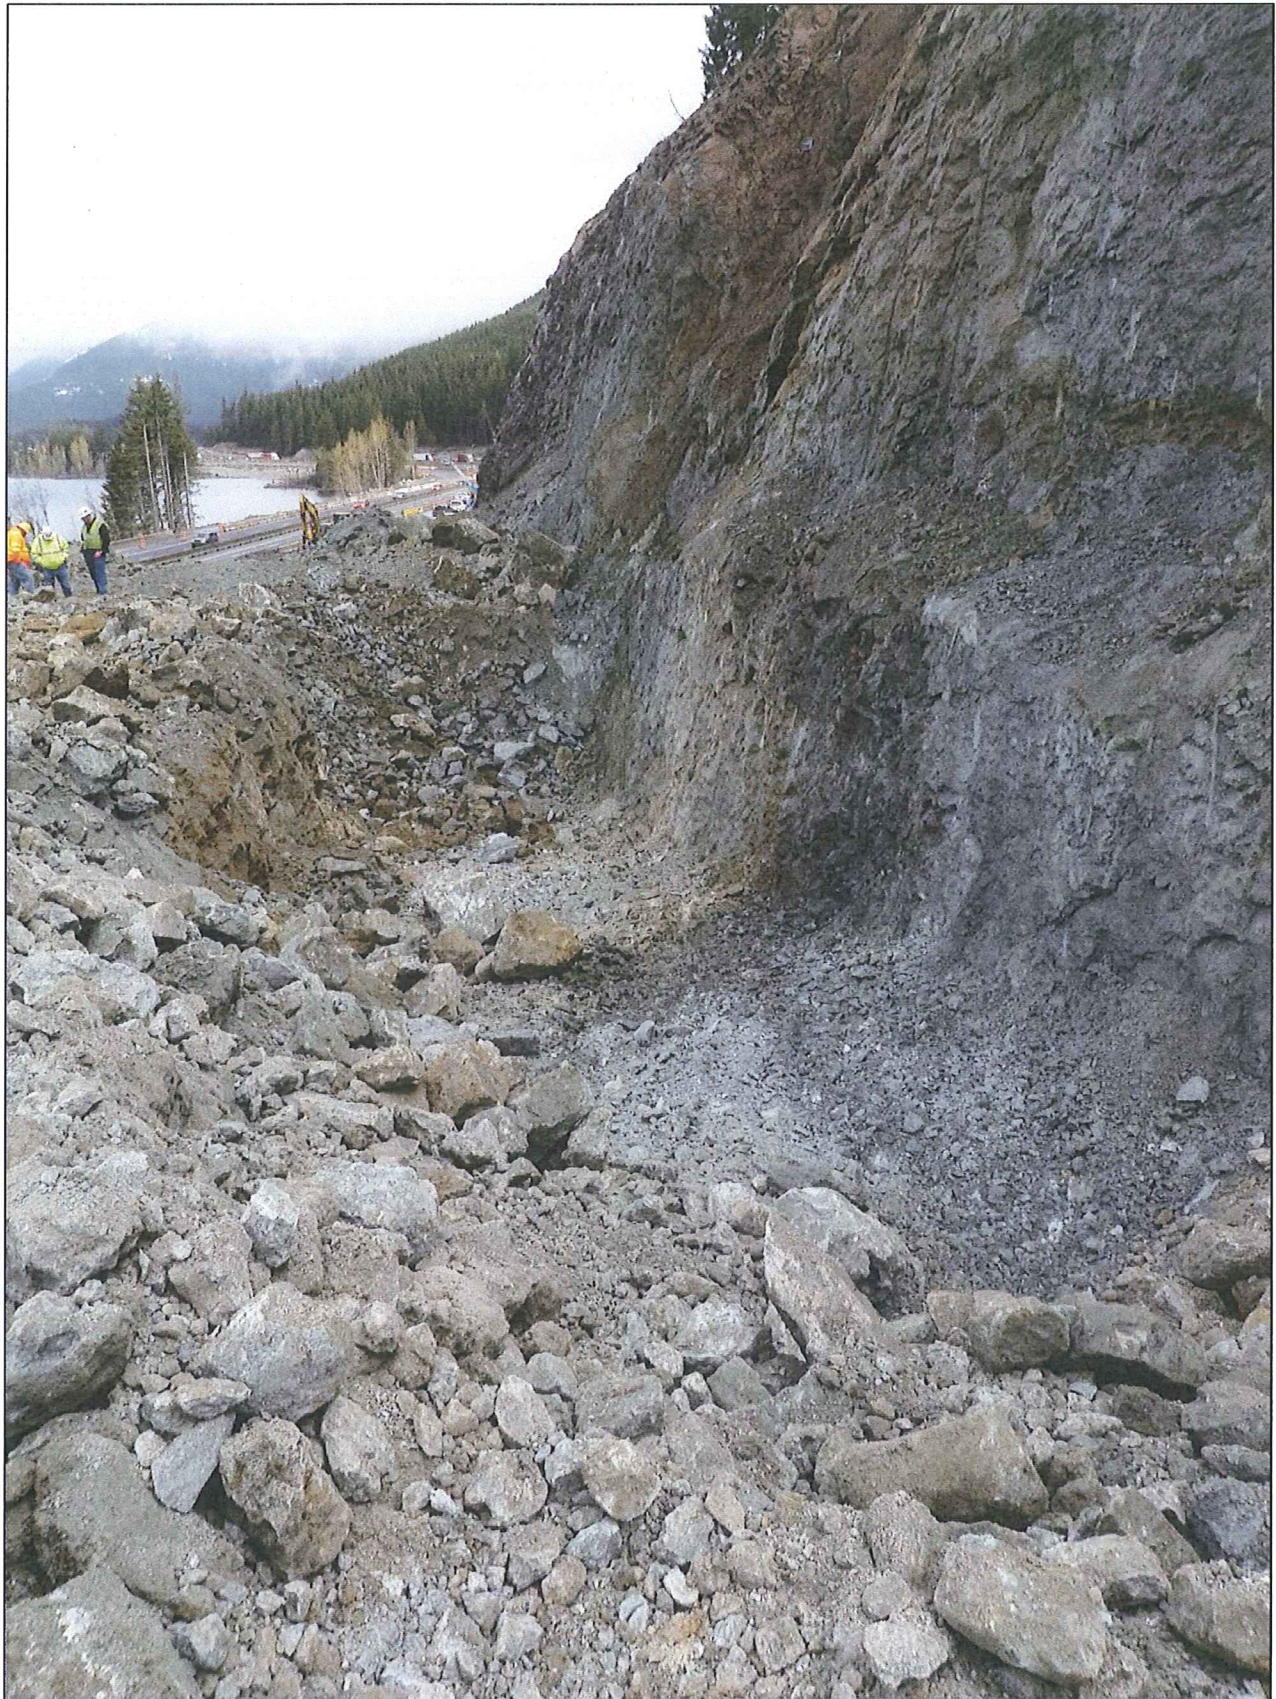
When asked about the shot, Brandon said the holes were filled with water and he was not happy with the fragmentation, but was pleased with the condition of the preshear face. Jerry Dilley and I agreed. To mitigate the oversized material in the body of the shots, Brandon recommended that they shorten up the burden and spacing of the buffer row in template #4 to a 6 by 6 pattern rather than the current 6 by 10 pattern and reduce the production pattern to an 8 by 8 with 3.5 inch holes rather than using the 10 by 10 with 4 inch holes. I asked that Brandon submit these proposed changes to Bob Hooker, so we could evaluate any changes prior to commencing the drilling of a new pattern. Brandon said he would submit these changes on Tuesday morning.

**Figure 2.** A photograph looking north at approximately LW Station 1327+75. Notice the oversized rock in the muck pile of the blast. If it weren't for the weak nature of the rock being readily broken down by the excavating equipment, I believe that the oversized materials would be much larger.
